Building Skin Care:

Tips to Maintain Historic Masonry Walls

By Frank Rosario

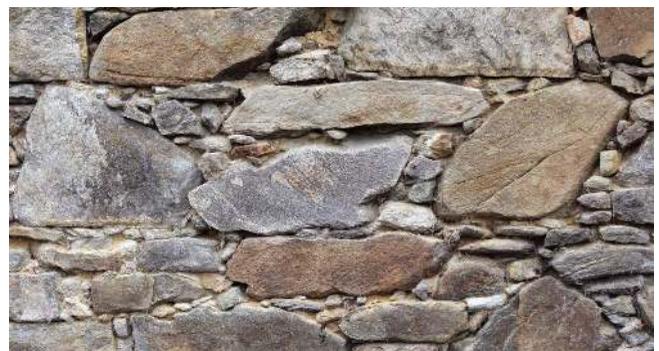
Stacked stones with pinnings deliver gravity forces to the ground.

Solid masonry walls exemplify time-tested methods of dry-stack and mortared-wall construction dating back millennia. Stable height-to-thickness arrangements of stone use friction fits and interlocking patterns to deliver gravity forces to the ground. Mortar facilitates the stacking and fills the joints. In contrast, the stacking of veneer masonry (stone or brick) relies on anchor ties to the back-up framing for stability, though outwardly the veneer may look very similar to a solid wall.

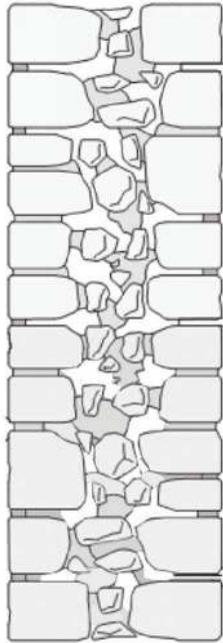
Figure 1: Voids in a solid masonry wall.

air-and-drainage cavity from which water that gets past the brick or stone is removed via flashing and weeps. Water vapor exits via the mortar joints in both wall types. And while there are voids inside walls of “solid” masonry, water is eliminated by evaporation, not drainage. The solid wall gets wet, holds the moisture within itself for a while, then dries out as relative humidity levels drop and evaporating water escapes via the most accommodating solid material, ideally the mortar. The rate at which this water vapor moves through a solid material is referred to as the material’s permeability. Use of a mortar that is harder than the original mortar can change this moisture mitigation dynamic.

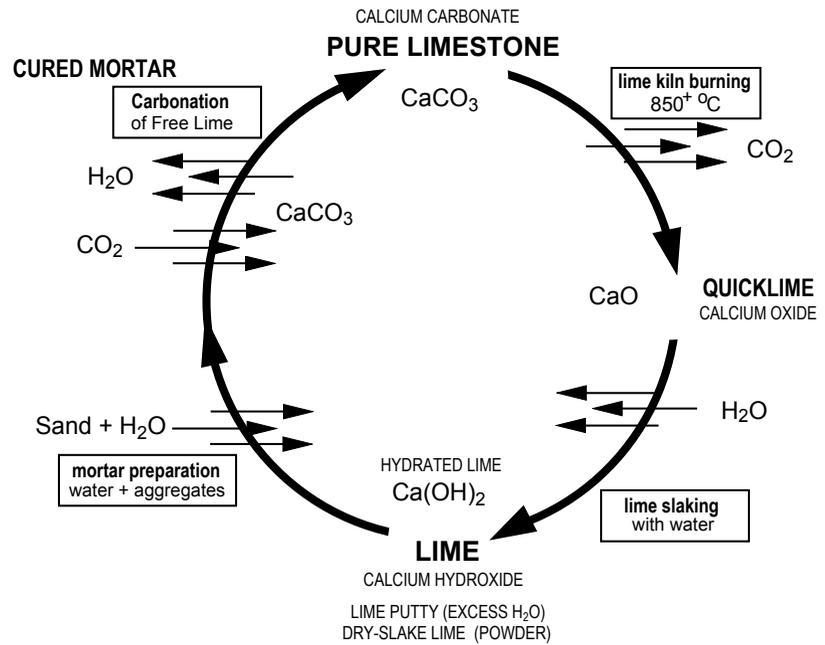
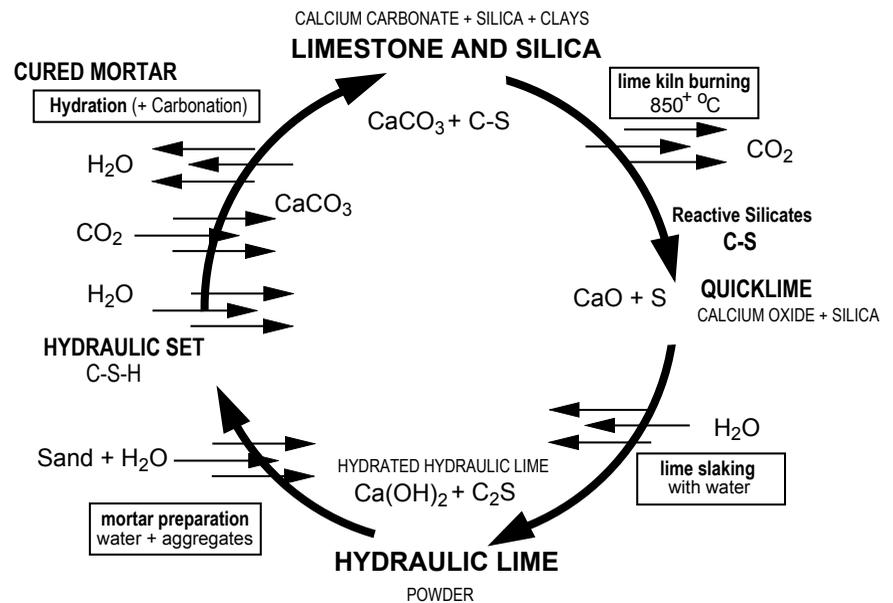
Figure 2: Production and curing of historic lime mortars.

The primary component of historic mortars was lime, a man-made product of natural limestone (calcium carbonate or CaCO_3) burned at high temperatures. The heat drives off carbon dioxide and any water, leaving calcium oxide, CaO , referred to as quicklime. After cooling, the quicklime was slaked, i.e., soaked in water, to produce lime putty - calcium hydroxide, $\text{Ca}(\text{OH})_2$. Lime putty was often left to mature for several months or even years.

At the time of a solid masonry wall’s original construction, mortar made of lime putty and sand was installed wet and allowed to cure slowly, hardening over many years from contact with the carbon

dioxide in the atmosphere to convert chemically back to limestone, a process referred to as carbonation. Sometimes clay impurities were burned with the crushed limestone to add a cementitious (adhering) quality to the mortar, and thus an accelerated setting time. These “natural cement” hydraulic lime mortars set by reaction with water rather than carbon dioxide and were especially valued where masonry was subjected to constant moisture antithetical to carbonation, such as lighthouses and aqueducts.

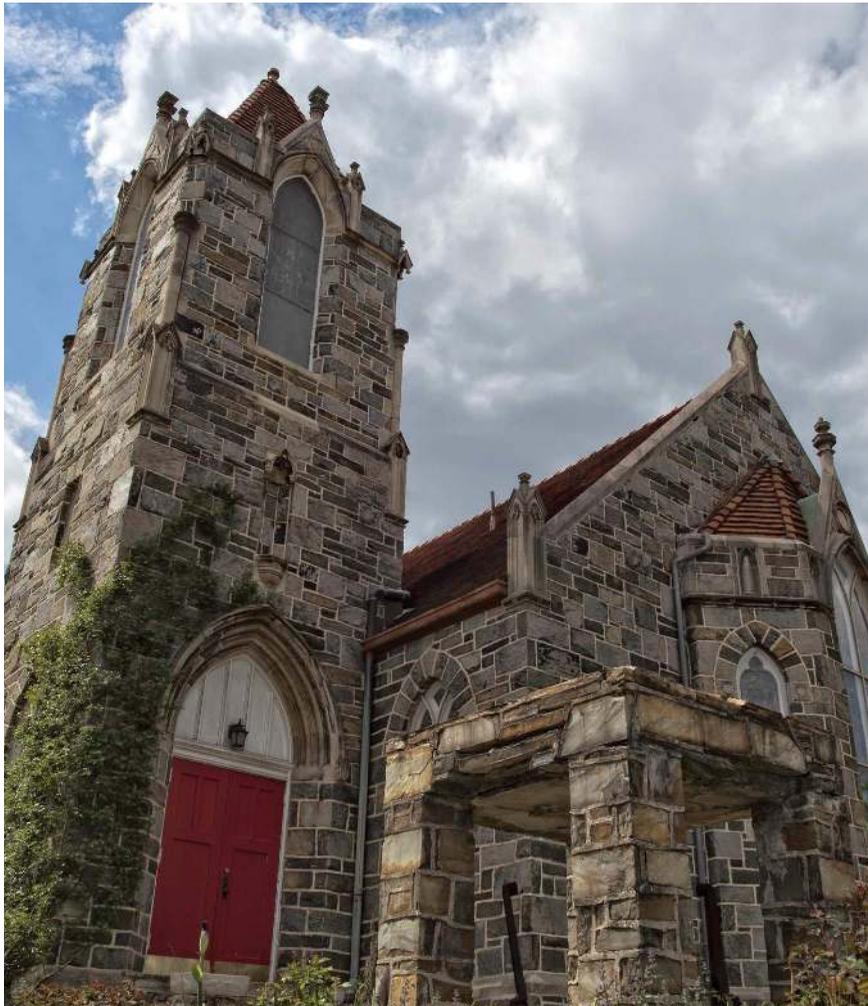
While the initial cost is high, repointing of historic masonry walls should not be postponed in favor of less expensive applications of vapor-blocking repellants, which can cause deterioration by trapping moisture.

Unfortunately, repointing is sometimes postponed in favor of a less costly application of water repellent—or worse, vapor-blocking paint. At best harmless but wholly ineffective, at worst an inhibitor to outward drying, this method does not mitigate unwanted moisture. Masonry conservators have discredited the practice yet it remains.

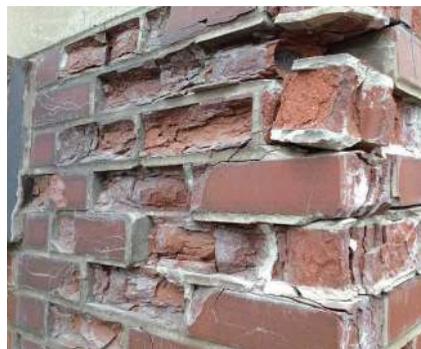
An example of spalled brick yet intact mortar.

Visual inspection of crumbled mortar and spalled masonry is a start. Has the wall been painted, and if so, is the paint a barrier to evaporation, thus causing spalling? Tapping/sounding masonry

faces for hollow-sounding areas can call attention to hidden disintegrated masonry that must be replaced. Look for brittle, cracked sealants that will admit water at window and door perimeters. Is there cement parging over parapet walls? It may no longer be effective if it is riddled with cracks. Staining around gutters, scuppers and downspouts is evidence of routine deluges down the wall face that will wash out even the best mortar. Are there building movement or settlement cracks? If so, repointing the symptom will not resolve the cause. Does the perimeter grade slope toward the base of the masonry wall?
